**Site Reassessment Report**  
**Cleveland Hopkins International Airport**  
**Cleveland, Ohio**

TDD No.:	S05-0701-011
Date Prepared:	April 22, 2008
Contract No.:	EP-S5-06-03
Prepared by:	STN Environmental JV
START Project Manager:	Karen Campbell
Telephone No.:	(312) 220-7005
U.S. EPA Site Assessment Manager:	Erica Islas
Telephone No.:	(312) 353-7209

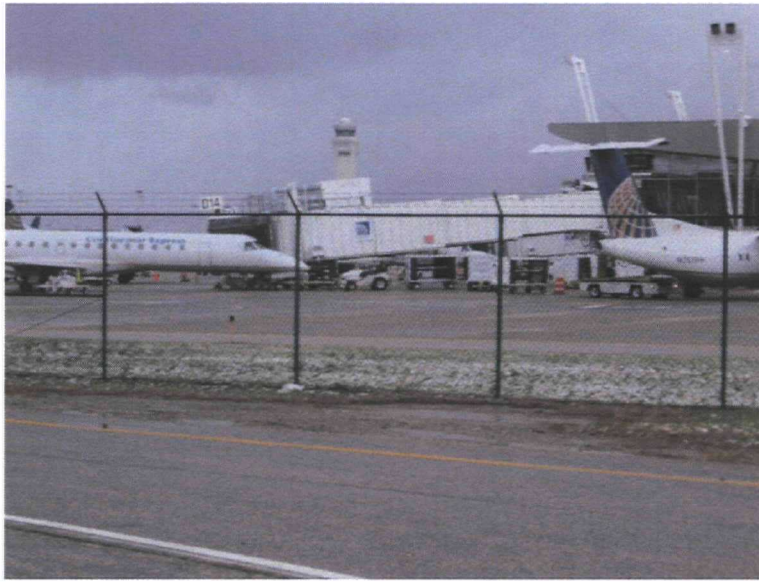
<b>Site:</b>	Cleveland Hopkins International Airport
<b>Date:</b>	December 3, 2007
<b>Photographer:</b>	Stephen Wolfe
<b>Photo Number:</b>	1
<b>Comment</b>	A view of the current conditions at the Burn Pit Area, Concourse "D".

Past investigations at the site included an assessment of subsurface contamination and a Human Health Risk Assessment. Under the Orders issued by OEPA, the Ohio Division of Emergency and Remedial Response (DERR) oversaw contaminated soil excavation from both burn pits. These areas were backfilled with clean soils. The smaller of the two burn pits is now located under Concourse D of the CHIA, and the other is an open field.

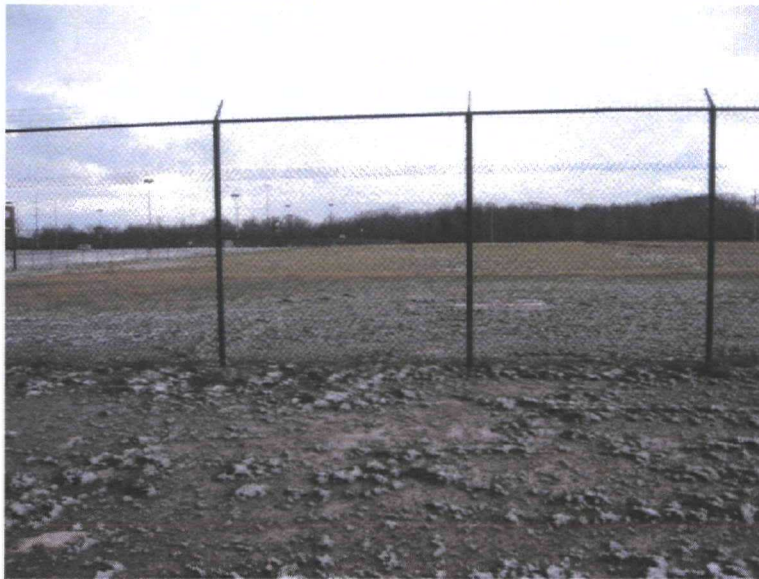
<b>Site:</b>	Cleveland Hopkins International Airport
<b>Date:</b>	December 3, 2007
<b>Photographer:</b>	Stephen Wolfe
<b>Photo Number:</b>	2
<b>Comment</b>	A view of the current conditions at the Burn Pit Area.

An airport expansion has occurred in one of the Burn Pit areas. This Burn Pit area is now paved and used as an airport runway and Concourse D, thereby eliminating soil exposure threats. The other Burn Pit area and the Ravine Site has been remediated and backfilled with clean soils therefore, eliminating potential soil contact/exposure threats. A runway expansion is currently in progress in the Excavation Area; therefore that area will be paved over also. Scenarios where CHIA workers would encounter on-site soils would include lawn maintenance personnel or construction workers for expansion projects. Therefore, the threat to environmental targets is considered low.

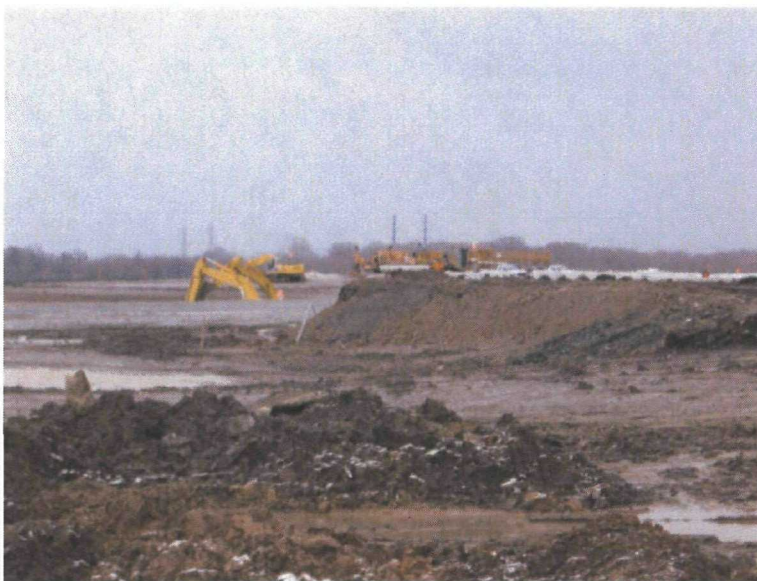
<b>Site:</b>	Cleveland Hopkins International Airport
<b>Date:</b>	December 3, 2007
<b>Photographer:</b>	Stephen Wolfe
<b>Photo Number:</b>	3
<b>Comment</b>	A view of the former Excavation Site. Currently undergoing a runway expansion.

**Excavation Area.** On March 10 and 11, 1988, CHIA personnel placed 148 drums, mostly empty, in a disposal pit located on the southwestern side of CHIA property. This pit was approximately 100 feet wide by 200 feet long. These drums were removed from the pit during the period of March 17 through 29, 1988. These drums were then staged at the site and disposed off in April 1990. These removal activities conducted at the site was regulated by DHWM personnel and was part of a RCRA closure, pursuant to OAC 3745-66-10. CHIA submitted a RCRA closure certification report to OEPA which was reviewed and approved in 1999. Currently this area is undergoing a runway expansion.

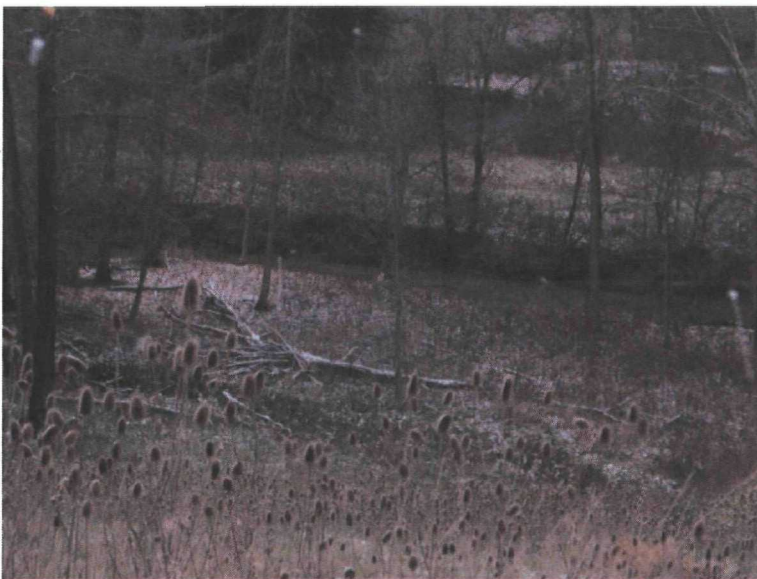
<b>Site:</b>	Cleveland Hopkins International Airport
<b>Date:</b>	December 3, 2007
<b>Photographer:</b>	Stephen Wolfe
<b>Photo Number:</b>	4
<b>Comment</b>	A view of the current conditions of the Ravine Area.

and a Phase I Remedial Investigation (RI) was performed during 1995 and a report was submitted in July 1996. The findings of the Phase I RI indicated that no further action was required. All work conducted at the Ravine Site was overseen by DERR personnel.
